Presentation Outline

RA Activities In Progress

Hunters Point Shipyard BCT Meeting – January 27, 2011

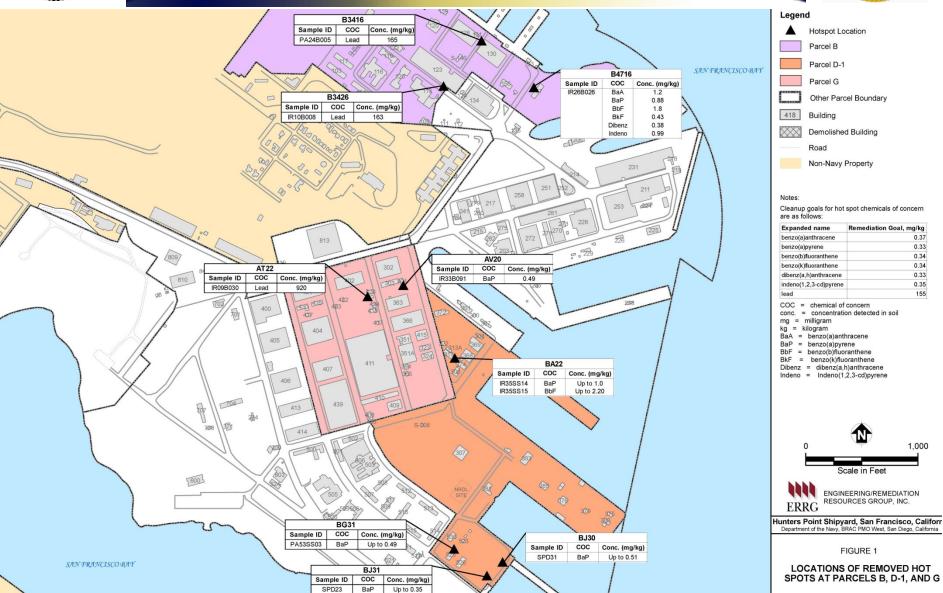
FIGURE 1

Soil Hot Spot Location Map

- Completed pre-excavation characterization sampling to delineate 9 of 11 hot spots; 2 hot spots not accessible in Parcel D-1
- All 9 hot spots excavated based on pre-excavation sampling results
- Sidewall and bottom confirmation sampling performed
- 2 of 9 hot spots required step-out excavation in one direction (B4716 and B3426)
- Additional confirmation samples collected at these 2 locations to verify complete removal of hotspot material
- Excavation B3426 required at least one additional step-out excavation – removal is ongoing
- All hot spots except B3426 were backfilled

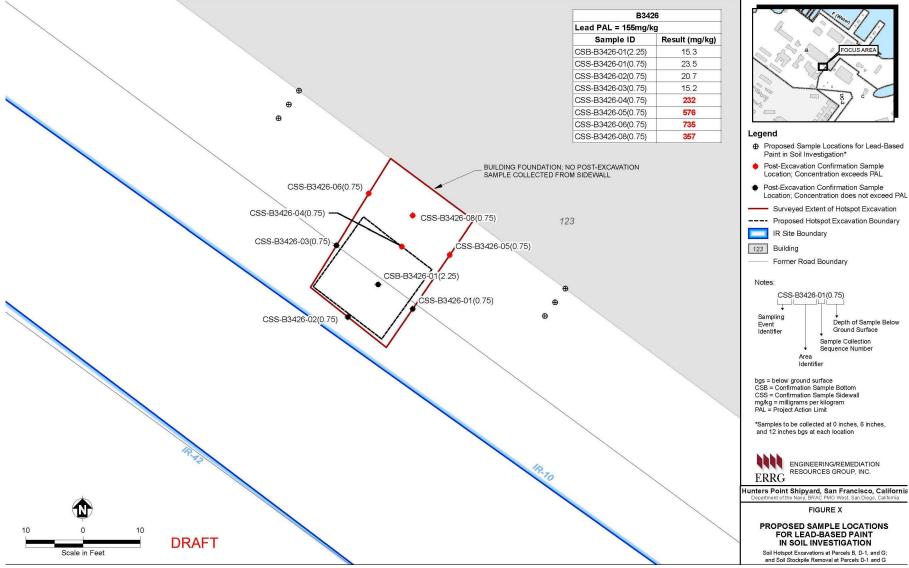
Proposed LBP Sampling Plan

- Lead concentrations in soil decrease with distance from the hotspot sample location, then increase in the direction of Bldg 123
- It is presumed that increasing lead concentrations in shallow soil near Bldg 123 are due to lead-based paint (LBP) contamination; not a CERCLA release
- The Navy proposes to perform a limited investigation to determine if lead in soil near Bldg 123 is related to LBP in soil
- Samples at various depths and distances from the building will be collected and analyzed for lead (away from the hotspot location)
- A sample of the paint on the building will be analyzed for lead
- If contamination is due to LBP, the Navy proposes to consider B3426 delineated and to backfill the excavation
- If contamination is not due to LBP, the Navy will proceed with step out excavation and confirmation sampling in accordance with the work plan

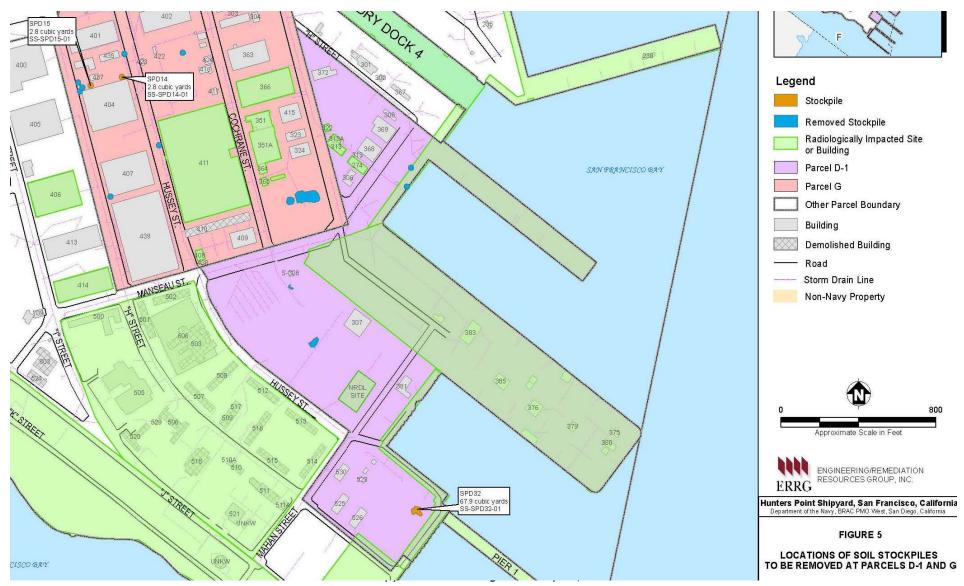
Soil Stockpile Location Map

- 15 of 18 stockpiles were removed prior to the start of this RA, leaving 3 requiring removal, characterization, and disposal
- 3 remaining stockpiles were relocated to on-site stockpile area in Parcel B; staged for off-site removal and disposal
- All stockpiles (and soil excavated from soil hotspots and from the shoreline of 7/18) were sampled for disposal profiling
- Soil load-out and disposal is being performed by the basewide non-radiological disposal contractor
- Soil will be disposed of as:
 - Class II non-hazardous waste (~6,000 tons)
 - CA hazardous waste due to soluble lead (~4,000 tons)

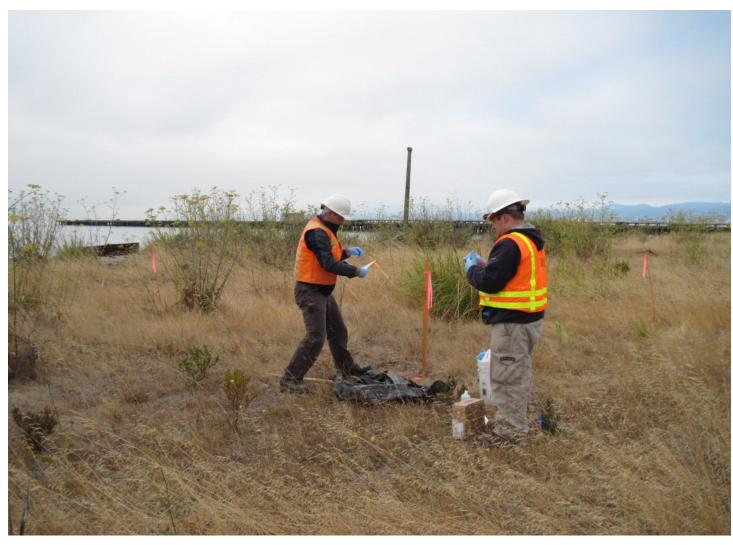
Hotspot Locations Delineated by Surveyor

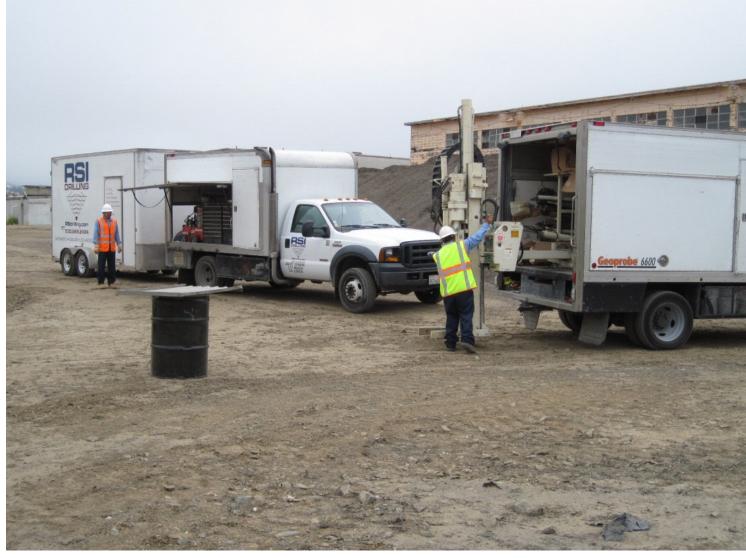
Drill Rig Used to Collect Pre-Excavation Samples at Hotspot Location

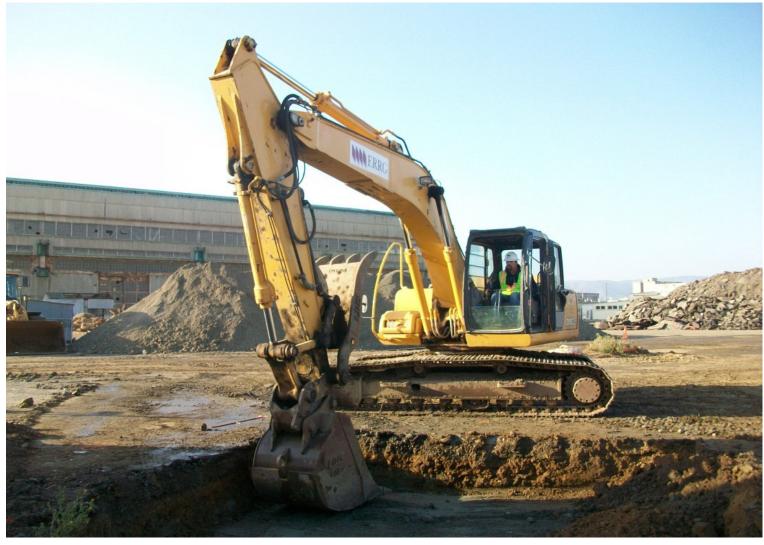
Excavation of Delineated Hot Spot

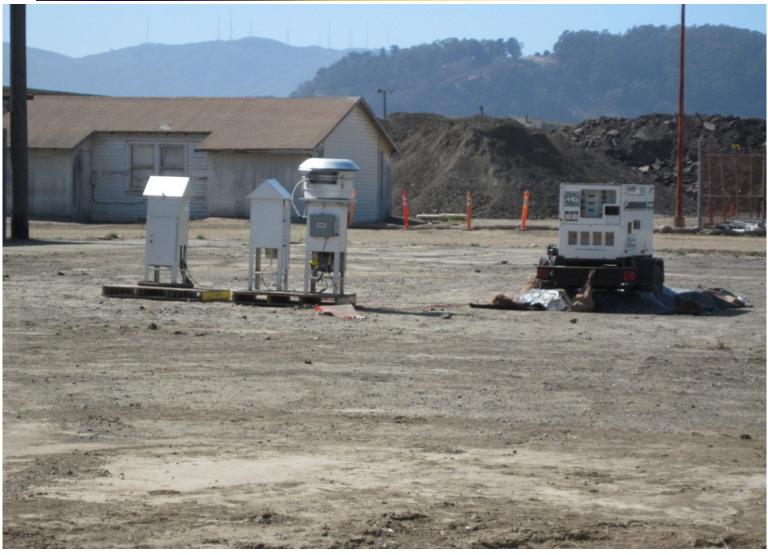
Air Monitoring Station Set Up at Hotspot Location

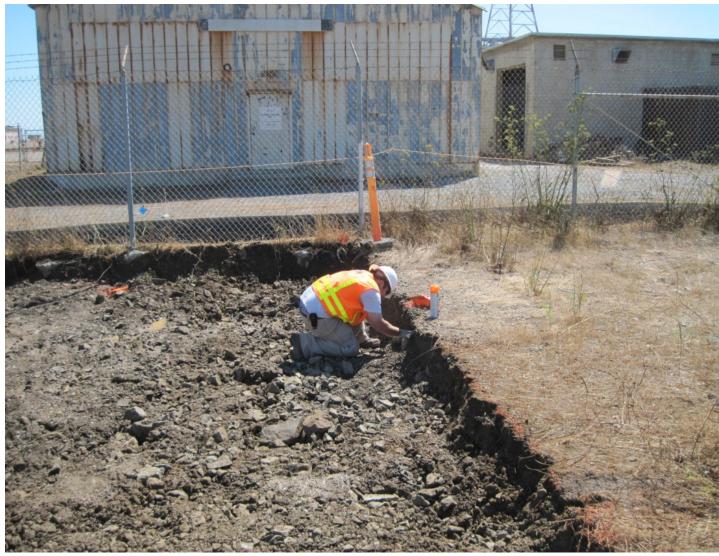
Confirmation Sampling at Hotspot Location

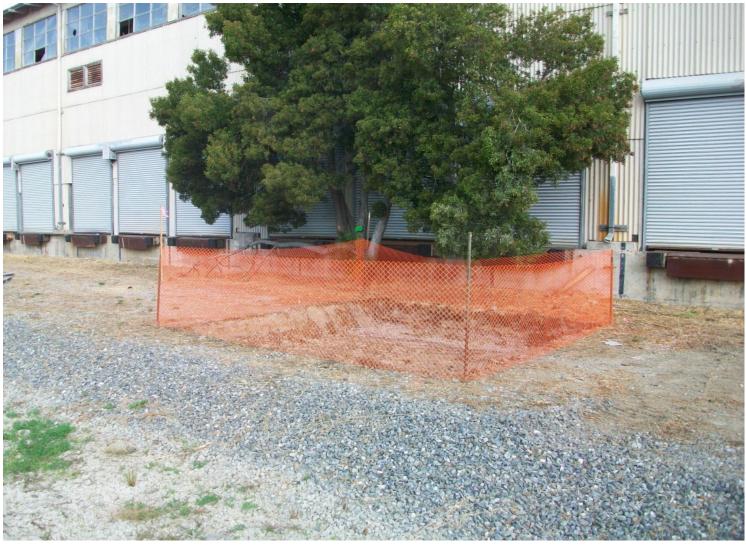
Secured Hotspot Excavation – Awaiting Confirmation Results

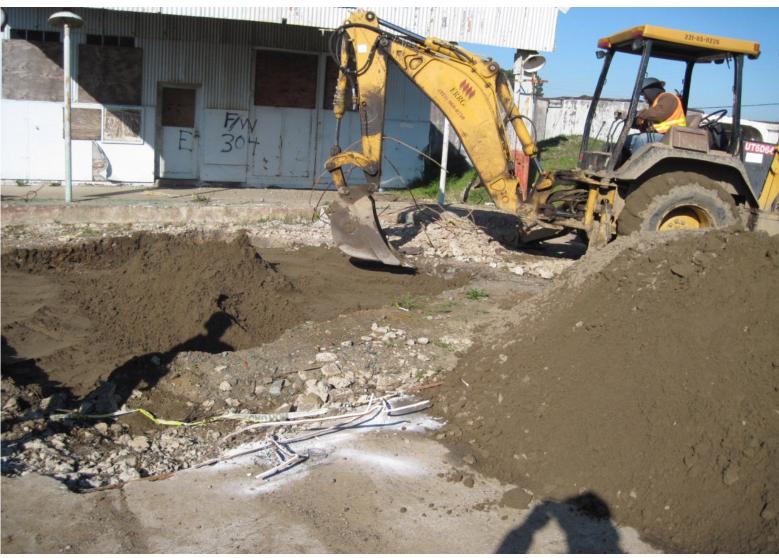
Backfilling Hotspot Excavation

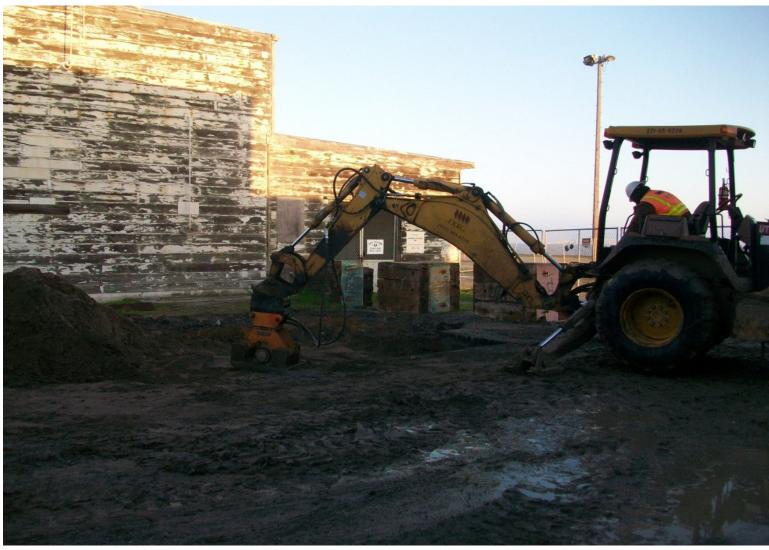
Hotspot Backfill Compaction Using a Vibratory Plate Compactor

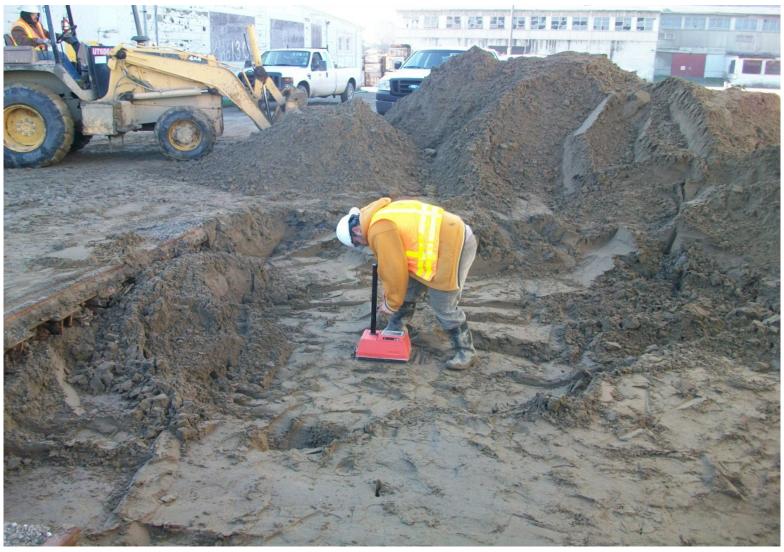
Nuclear Density Gauge Used to Verify Backfill Compaction Density

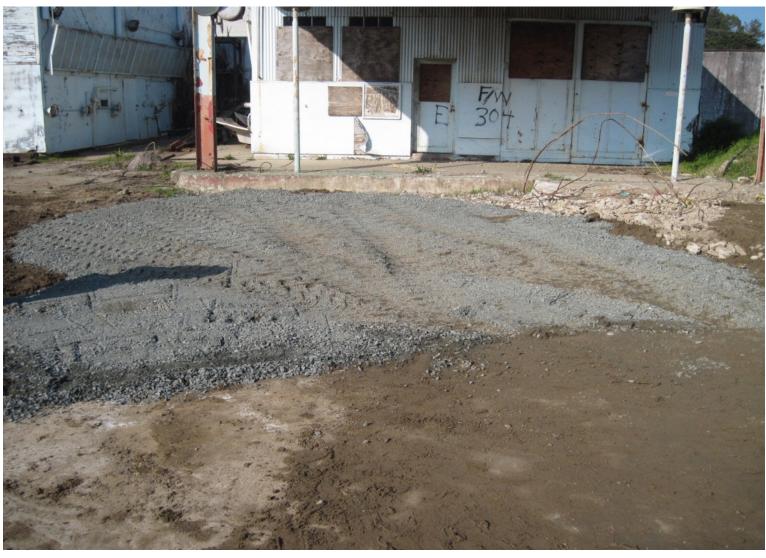
Backfilled Hotspot Excavation
